In-Site Inspections

Property Inspection Report

2744 North White Pines Drive, Coeur d'Alene ID, 83815
Inspection prepared for: Dan Davis & Joann Davis
Inspection Date: 5/25/2010 Time: 11:00 am
Age: 15 Size: 2,800
Weather: Overcast

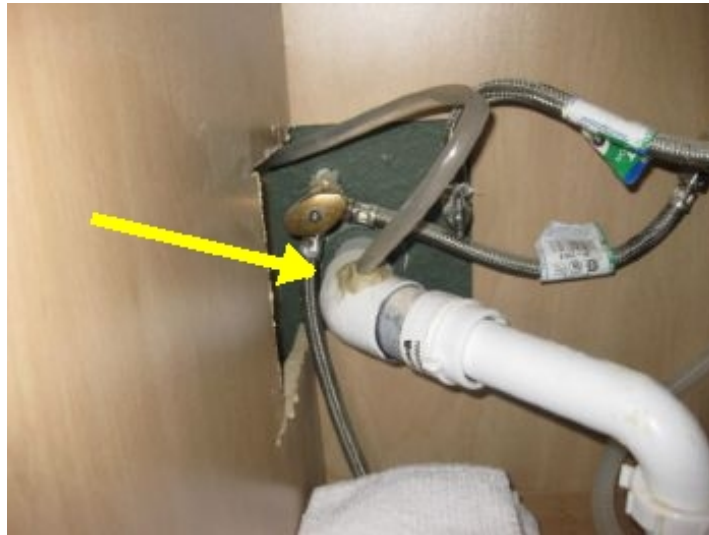
- GFCI outlet tested and operated.
- Ice maker drain improperly plumbed.

Ice maker improperly drained at bsmt. wet bar.

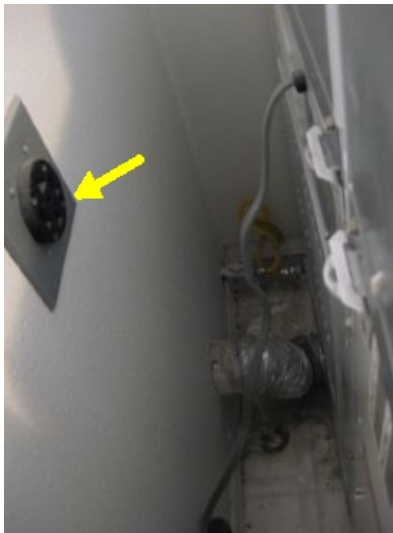
Observations:
 • Loop in flex vent behind dryer could accumulate lint and pose a fire hazard.

Observations:
 • Laundry room dryer electrical circuit is dead. Circuit has been used for heat pump eliminating the possibility of an electric dryer. Gas is present and being used.

Dead dryer outlet and looped dryer flex vent.

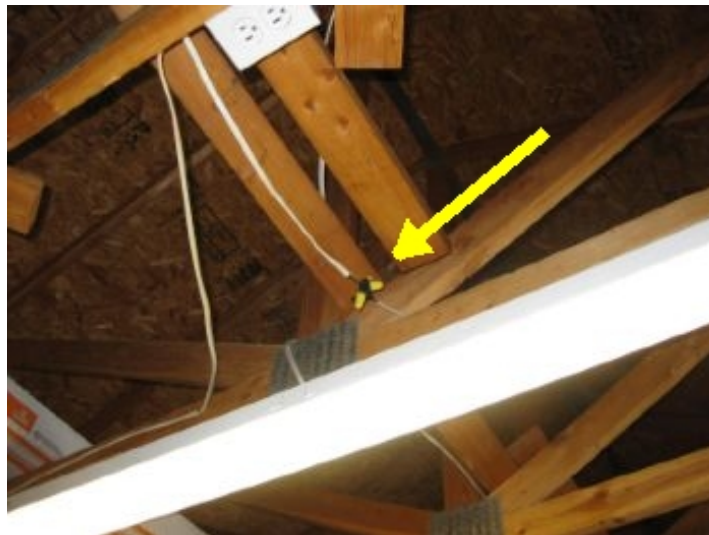
Observations:
• Exposed wire connection in garage attic.

Exposed wire connection in garage attic.

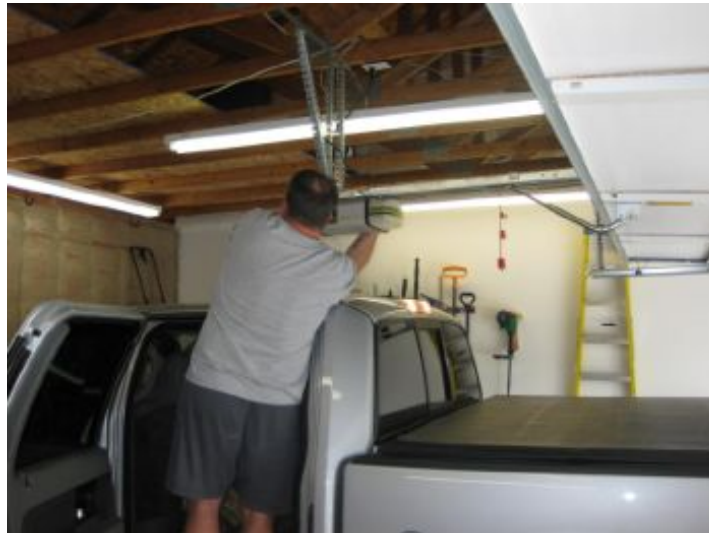
Garage door does not reverse with contact. Client attempting repair.

- The door requires a great deal of resistance to trigger the auto-reverse mechanism. We recommend adjusting the opener for proper reverse tension.
- Eye beam system present and operating.

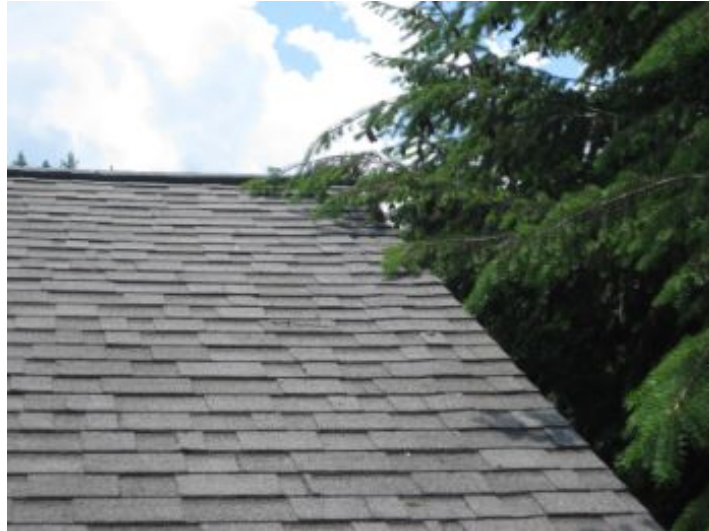
- No major system safety or function concerns noted at time of inspection.
- Recommend removing tree branches than contact shingles at garage roof.

Trim brancehs to avoid excess wear.

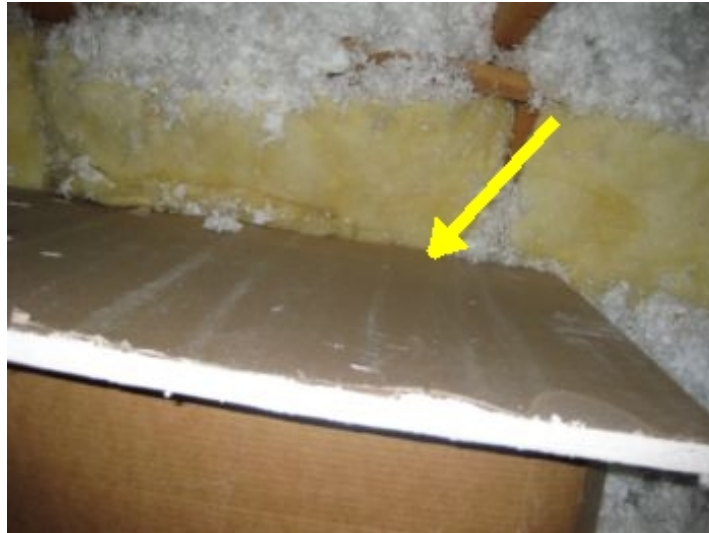
Attic Access

- Access at hallway ceiling
- **IMPROVE:** The attic access is not insulated. Expect some energy loss through convection. Recommend insulating attic access hatch cover with a batt of fiberglass insulation to reduce energy expenses.
- 2 ventilation fans have been serviced/installed and insulation was not replaced in these areas.

- No insulation over attic hatch; recommend installation, then sealing hatch with caulk to minimize heat loss.
- Insulation level in the attic is typical for homes this age
- **Insulation not replaced after install/service of two ventilation fans.**

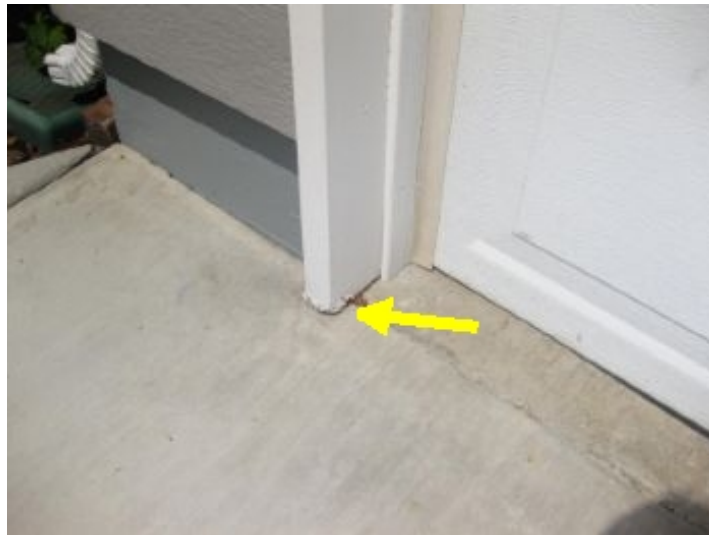
Trim wicking moisture and rotting.

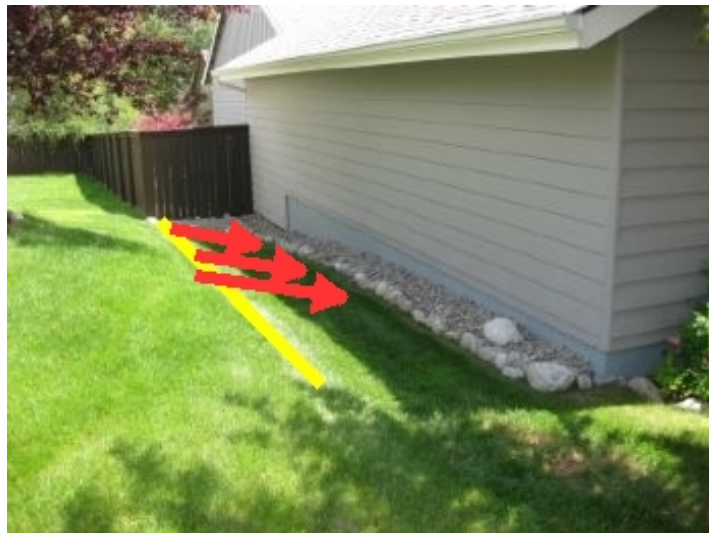
- **Negative slope at west elevation contributing to water issues in crawl space.**

Negative slope contributes to damp crawl space.

- Lot grading and drainage have a significant impact on the building, simply because of the direct and indirect damage that moisture can have on the foundation. It is very important, therefore, that surface runoff water be adequately diverted away from the home. Lot grading should slope away and fall a minimum of one (1) inch every foot for a distance of six (6) feet around the perimeter of the building.

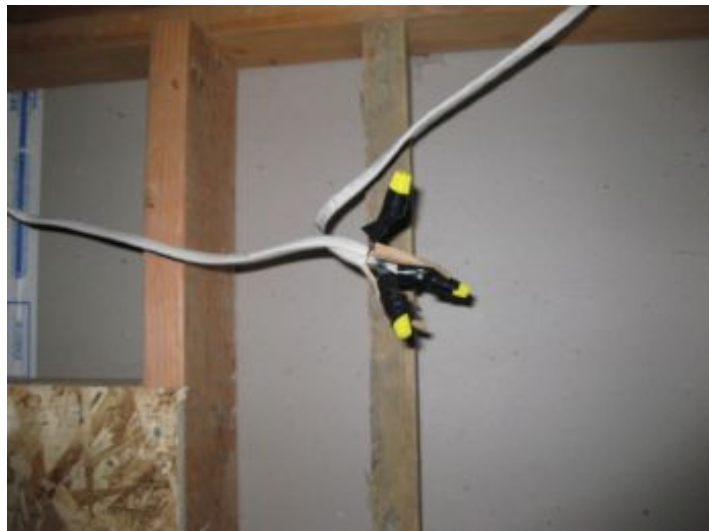
- 3 electrical connections noted in the crawl space that are not in junction boxes. Must be repaired.

One of 3 similar exposed connections.

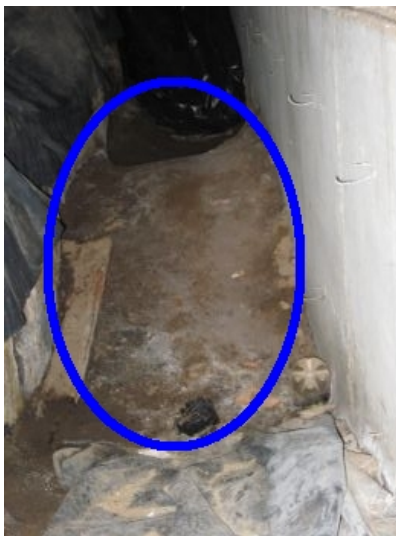
- Recommend further review of current perimeter foundation drainage system by a Qualified Foundation Drainage Contractor. Drain pit appears to be insufficient and may allow water to enter structure in the event of a heavy rainfall.

EWxpopped dirt and standing water in crawl space
